**Flood Control Project Maintenance
Levee Inspections**
LMA District Cover Sheet
Spring 2020 Levee Inspection Results

Lower San Joaquin Levee District

Spring 2020 Levee Inspection Results

Waterway			Bank	Unit Miles
Unit No. 01 San Joaquin River			Right	22.52
	Spring (March - May)	Summer (June - August)	(September - November) Fall	Winter (December - February)
Unit Maintenance Rating (Fall Only)				
Date of Inspection	4/21/2020 - 4/21/2020			
DWR Inspector	Corey Fujitani			
Accompanied By

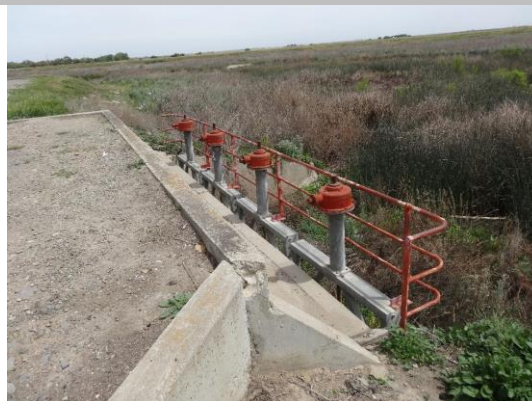
Photo 3 of 3 : UCIP_SP_2020_36875_67306.jpg

Concrete headwall located on waterward side.

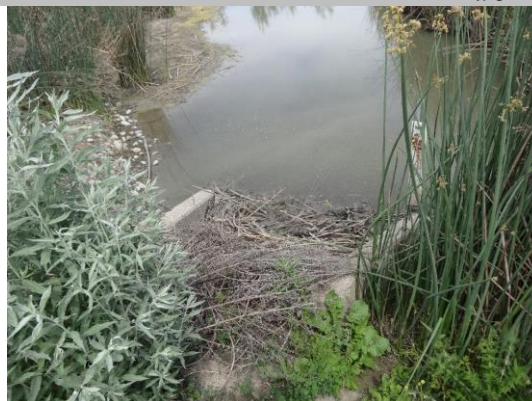
Photo 1 of 3 : UCIP_SP_2020_34093_61982.jpg

Comment Code						
Inspector Comment						
DS_ID:19695 FS_ID:34093 EP_NO: N/A Repair Type: Non-Urgent Crossing Status: Found UCIP Comments: 04/17/2014 Sediment and debris blocking concrete headwall located on waterward side. During inspection water was flowing from landward side to waterward side. Recommend removing sediment to confirm condition of flap gate and pipe. (DWR UCIP - O. Magana) FIELD_STRUCT_DESC: 36-inch corrugated metal gravity drainage pipe through the levee, 18 feet below the crown. Flap gate on the waterside (WS) end. Concrete headwall on each end. [Additional Reference(s): DWR Levee Log, 2002. USACE San Joaquin O&M Manual 601.1, 1967, (HLM 0.27)]. FS Date: 4/17/2014

View of dense vegetation near concrete headwall located on waterward side.

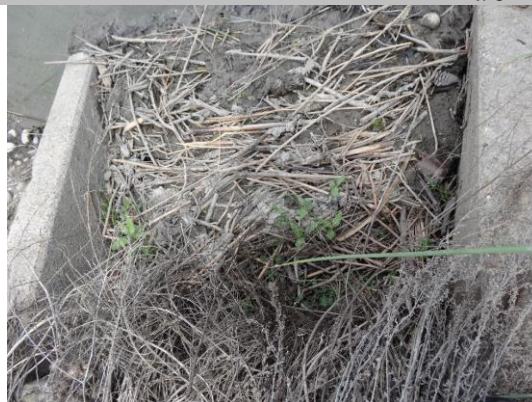
Photo 2 of 3 : UCIP_SP_2020_34093_61981.jpg

Sediment blocking flap gate located on waterward side.

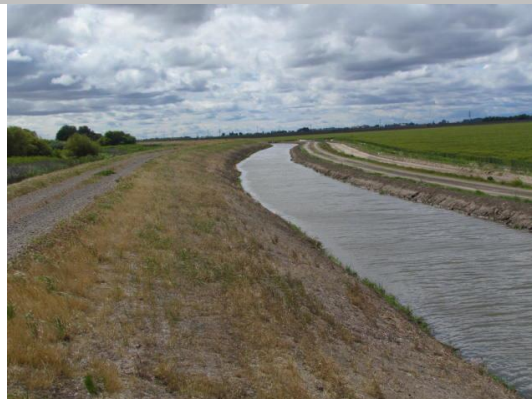
Photo 1 of 1 : SP_2020_NA0010_122_3_20200225_00001.jpg

LM Start	0.32	Rating **	M	Issue No.	3
LM End	1.41	Issue Type +	En	Location *	LS
Category	Earthen Levee			GPS Latitude/Longitude	
				Start	End
Item	Encroachments			37.108822 °	37.097556 °
				-120.590718 °	-120.578130 °
DWR ID	DWR_NA0010_04_s_2012_3				
Comment Code					
DT : Ditch					
Inspector Comment					
An irrigation ditch is within 10' easement.

Looking north at irrigation ditch at landside toe.

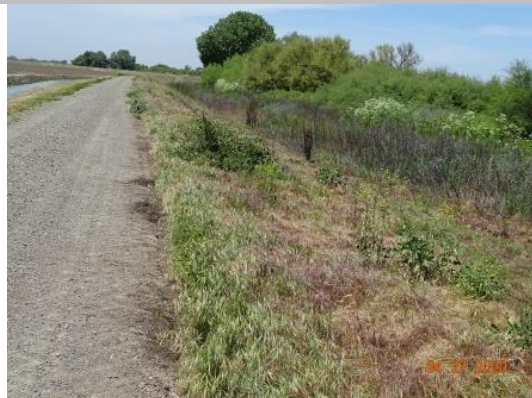
Photo 1 of 1 : SP_2020_NA0010_122_9_20200506_00023.jpg

LM Start	0.44	Rating **	M	Issue No.	9
LM End	1.39	Issue Type +	Ma	Location *	WS
Category	Earthen Levee			GPS Latitude/Longitude	
				Start	End
Item	Vegetation			37.107264 °	37.097745 °
				-120.589747 °	-120.578145 °
DWR ID	DWR_NA0010_04_s_2020_9				
Comment Code					
V1 : Control annual grass and weeds on the levee slopes and easements.					
Inspector Comment

View of vegetation looking downstream along the waterside slope.
(Spring 2020)

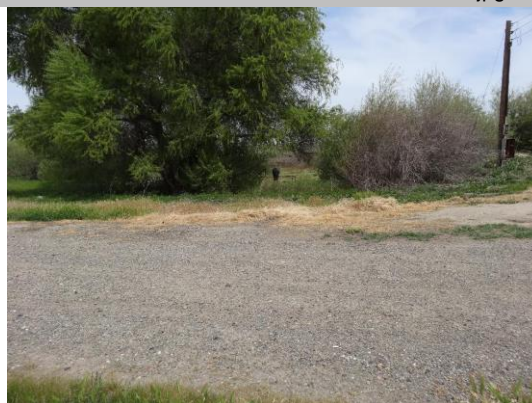
Photo 1 of 3 : UCIP_SP_2020_40530_61987.jpg

LM Start	1.34	Rating **	M	Issue No.	15
LM End	1.34	Issue Type +	En	Location *	
Category	Supplemental			GPS Latitude/Longitude	
				Start	End
Item	DWR UCIP Field Study			37.095274 °	37.095274 °
				-120.577959 °	-120.577959 °
DWR ID	19975				
Comment Code					
Inspector Comment					
DS_ID:19975 FS_ID:40530 EP_NO: 3416 Repair Type: Non-Urgent Crossing Status: Found UCIP Comments: Unable to confirm if crossing is still in use. Need to contact owner to confirm status. FIELD_STRUCT_DESC: 12-inch steel irrigation pipe, encased in 6-inches of reinforced concrete through the levee. Concrete cutoff wall at center of levee. Pumping plant on the waterward bank. Pump and irrigation pipe retained under Permit No. 3416 (1964). FS Date: 4/17/2014

View of waterward side.

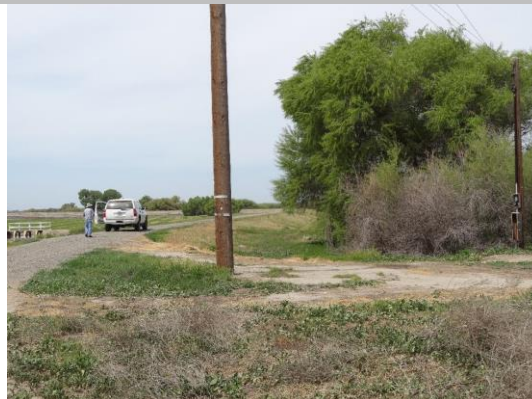
Photo 2 of 3 : UCIP_SP_2020_40530_61988.jpg

Overview of waterward side and levee crown at crossing.

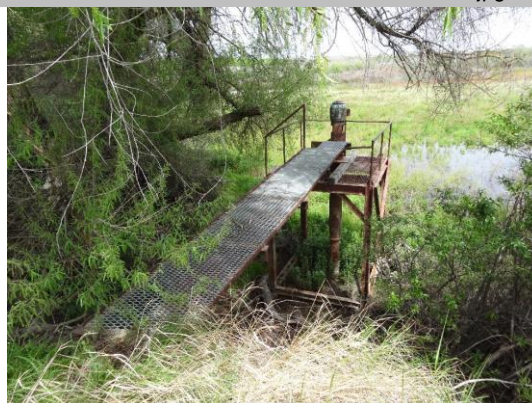
Photo 3 of 3 : UCIP_SP_2020_40530_61986.jpg

Pump and walkway located on waterward side.

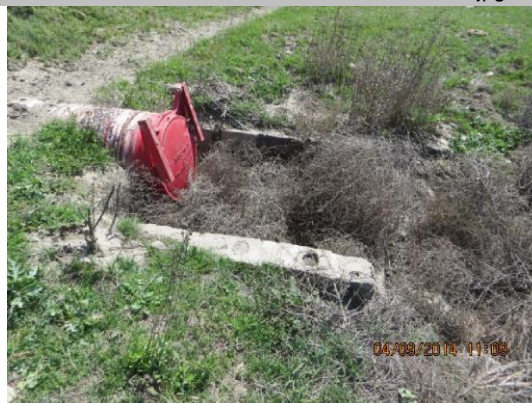
Photo 2 of 3 : UCIP_SP_2020_39563_60920.jpg

Pipe, flapgate, and concrete headwall on WS toe.

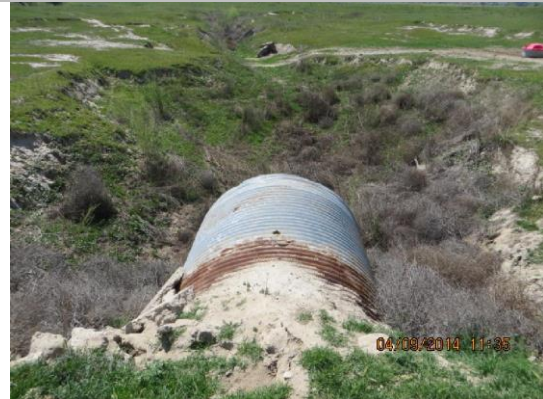
Photo 2 of 3 : UCIP_SP_2020_53185_71467.jpg

UCIP Comments: 11/01/2018 Same as previous inspection, 1960s levee breach; degraded levee section that drops about 4 feet within a 100-foot levee section. Crossing remains Urgent due to the levee degradation at this location. (O. Magana - DWR UCIP)07/20/2016 same as previous inspection. Levee section at crossing has been degraded. According to LMA representative, Rick, the low point at crossing has been present for over 10 years when the pipe was replaced. (DWR UCIP - O. Magana)04/09/2014 Pipe is open on both ends and levee has been degraded at this location. No permit identified for this crossing. (DWR UCIP - W. Wylie)

Pipe on WS toe.

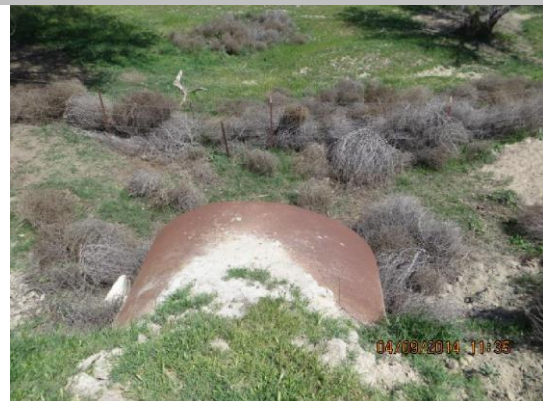
Photo 3 of 3 : UCIP_SP_2020_53185_71468.jpg

Pipe on LS toe.

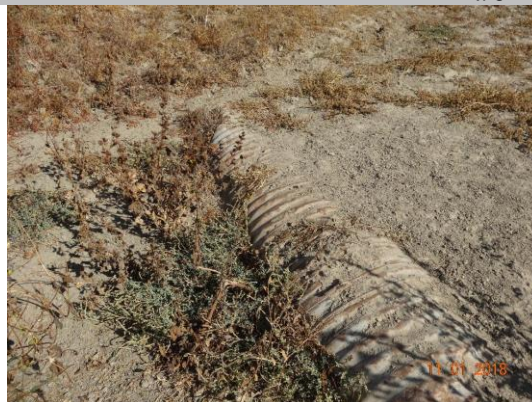
Photo 2 of 3 : UCIP_SP_2020_53194_78593.jpg

LS view: CMP section found on LS.

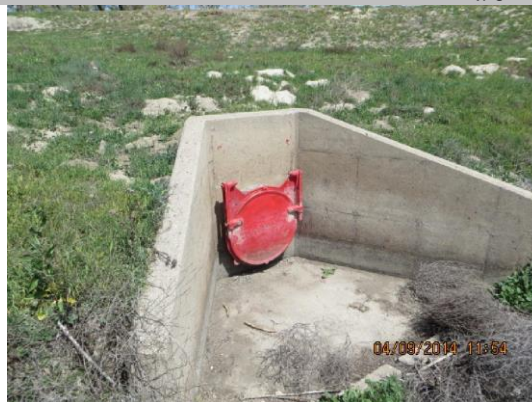
Photo 2 of 3 : UCIP_SP_2020_39585_60929.jpg

Pipe, flapgate, and headwall at WS toe.

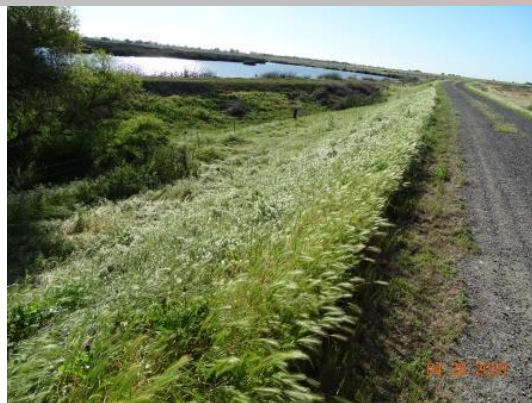
Photo 1 of 1 : SP_2020_NA0010_123_126_20200506_00343.jpg

LM Start	0.67	Rating **	U	Issue No.	126
LM End	1.94	Issue Type +	Ma	Location *	LS
Category	Earthen Levee			GPS Latitude/Longitude	
				Start	End
Item	Vegetation			37.273226 °	37.260707 °
				-120.814911 °	-120.799490 °
DWR ID	DWR_NA0010_05_s_2020_126				
Comment Code					
V1 : Control annual grass and weeds on the levee slopes and easements.					
Inspector Comment

View of the landside slope looking upstream. (Spring 2020)

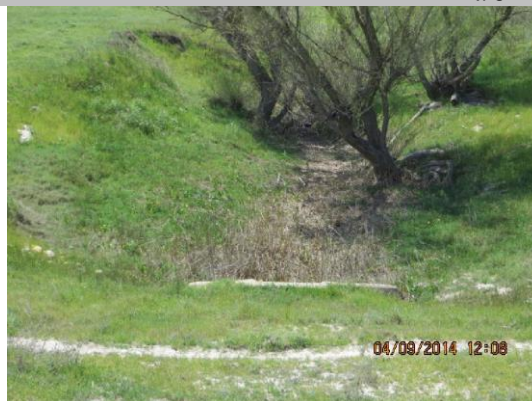
Photo 1 of 3 : UCIP_SP_2020_33707_60934.jpg

LM Start	0.85	Rating **	A/W	Issue No.	1315
LM End	0.85	Issue Type +	Ma	Location *	
Category	Supplemental			GPS Latitude/Longitude	
				Start	End
Item	DWR UCIP LMA Responsibility			37.271894 °	37.271894 °
				-120.812224 °	-120.812224 °
DWR ID	19759				
Comment Code					
Inspector Comment					
DS_ID:19759					
FS_ID:33707					
EP_NO: N/A					
Repair Type: No Action Needed					
Crossing Status: Found					
UCIP Comments:					
FIELD_STRUCT_DESC: 24-inch corrugated metal gravity drainage pipe through the levee, 14.4 feet below the crown. Flap gate on the waterside (WS) end. Concrete headwall on the landside (LS) end. Concrete U-shaped headwall on the WS end. [Additional Reference(s): DWR Levee Log, 2002. USACE San Joaquin O&M Manual 601.1, 1967, (HLM 0.84)].					
FS Date: 4/9/2014

Concrete headwall visible at LS toe.

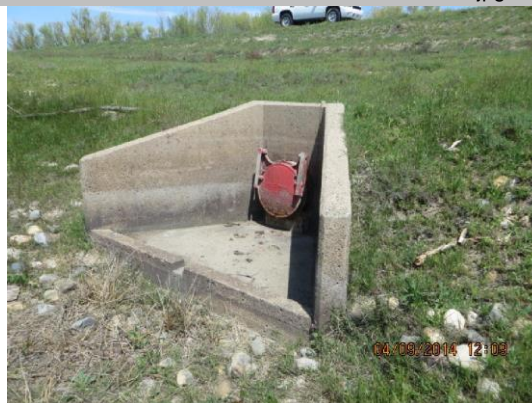
Photo 2 of 3 : UCIP_SP_2020_33707_60933.jpg

Pipe, flapgate, and headwall at WS toe.

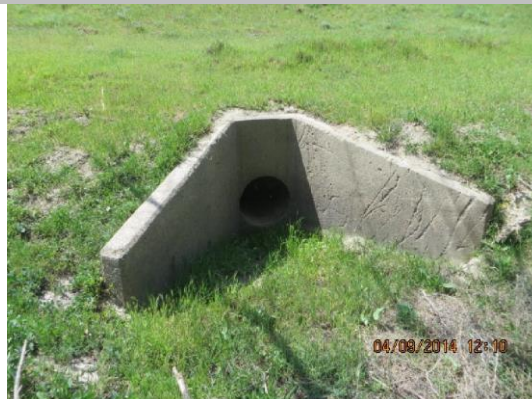
Photo 3 of 3 : UCIP_SP_2020_33707_60936.jpg

Pipe and concrete headwall at LS toe.

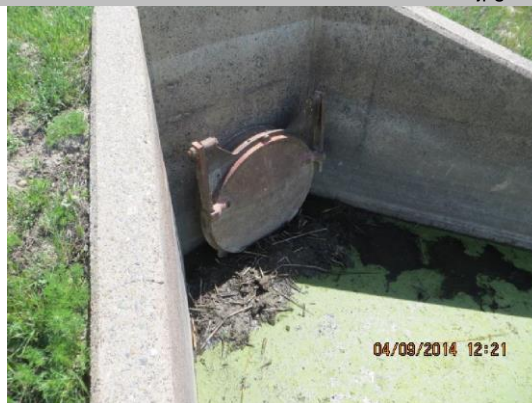
Photo 2 of 3 : UCIP_SP_2020_33708_60938.jpg

Flapgate on concrete headwall at WS toe.

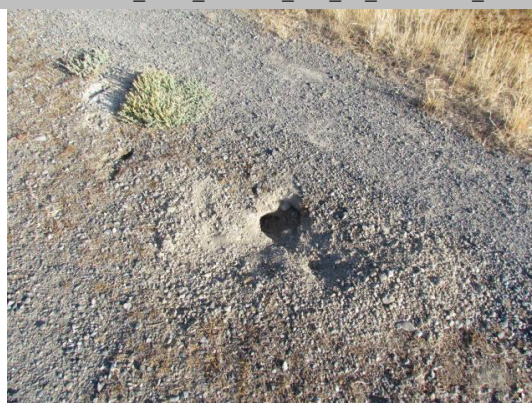
Photo 1 of 1 : SP_2020_NA0010_123_80_20200225_00013.jpg

LM Start	1.66	Rating **	M	Issue No.	80
LM End	1.75	Issue Type +	Ma	Location *	LS
Category	Earthen Levee			GPS Latitude/Longitude	
				Start	End
Item	Animal Control			37.263448 °	37.262225 °
				-120.802715 °	-120.802296 °
DWR ID	DWR_NA0010_05_f_2015_80				
Comment Code					
A3 : No rodents visible, but rodent burrows visible; need to backfill and compact or grout burrows.					
Inspector Comment					
Several rodent holes are located on levee crown and landside slope within this section.

Looking at typical view of rodent holes within this section on landward slope.

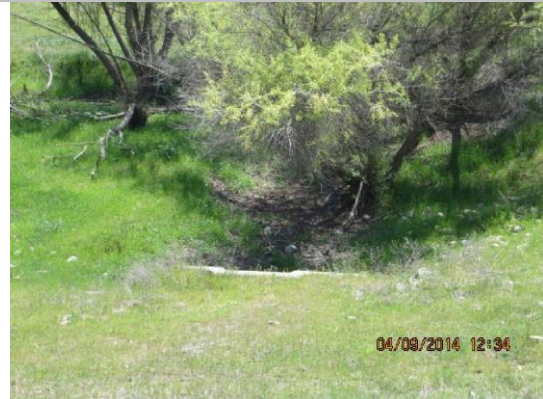
Photo 1 of 3 : UCIP_SP_2020_33709_60943.jpg

LM Start	2.84	Rating **	M	Issue No.	1317
LM End	2.84	Issue Type +	Ma	Location *	
Category	Supplemental			GPS Latitude/Longitude	
				Start	End
Item	DWR UCIP LMA Responsibility			37.256810 °	37.256810 °
				-120.785113 °	-120.785113 °
DWR ID	19809				
Comment Code					
Inspector Comment					
DS_ID:19809					
FS_ID:33709					
EP_NO: N/A					
Repair Type: Non-Urgent					
Crossing Status: Found					
UCIP Comments: 04/09/2014 Log partially blocking inlet at LS toe.					
(DWR UCIP - W. Wylie)					
FIELD_STRUCT_DESC: 24-inch corrugated metal gravity drainage					
pipe through the levee, 15 feet below the crown. Flap gate on the					
waterside (WS) end. Concrete U-shaped headwall on each end.					
[Additional Reference(s): DWR Levee Log, 2002. USACE San Joaquin					
O&M Manual 601.1, 1967, (HLM 2.85)].					
FS Date: 4/9/2014

Concrete headwall at outlet on WS toe.

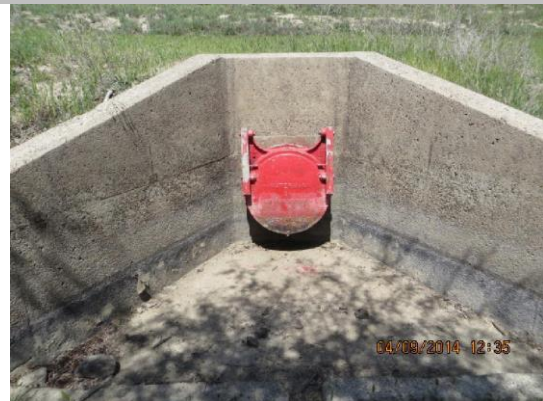
Photo 2 of 3 : UCIP_SP_2020_33709_60941.jpg

Headwall, pipe, and flapgate on WS toe.

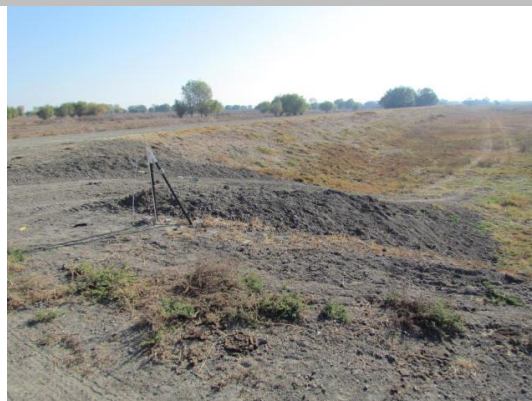
Photo 1 of 1 : SP_2020_NA0010_123_7_20200225_00005.jpg

LM Start	3.20	Rating **	M	Issue No.	7
LM End	3.20	Issue Type +	En	Location *	WS
Category	Earthen Levee			GPS Latitude/Longitude	
				Start	End
Item	Encroachments			37.256554 °	37.256554 °
				-120.778847 °	-120.778847 °
DWR ID	DWR_NA0010_05_f _ 2012_7				
Comment Code					
RA : Ramp					
Inspector Comment					
An unauthorized ramp is located on the waterside slope.

Looking south at unauthorized ramp on waterside slope.

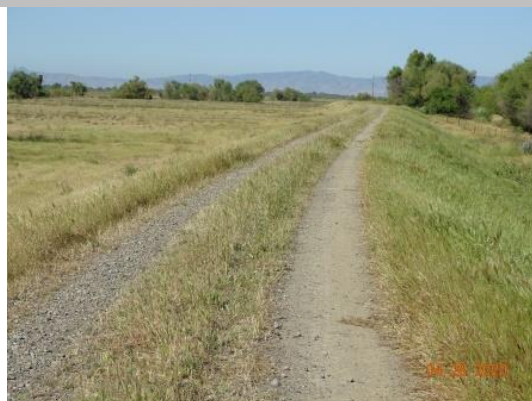
Photo 1 of 1 : SP_2020_NA0010_123_193_20200506_00344.jpg

LM Start	3.21	Rating **	M	Issue No.	193
LM End	3.62	Issue Type +	Ma	Location *	CR
Category	Earthen Levee			GPS Latitude/Longitude	
				Start	End
Item	Vegetation			37.256518 °	37.255564 °
				-120.778807 °	-120.772381 °
DWR ID	DWR_NA0010_05_s_2020_193				
Comment Code					
V9 : Keep the crown roadway free of vegetation.					
Inspector Comment					
end at start of unit 7.

Looking downstream along the levee crown. (Spring 2020)

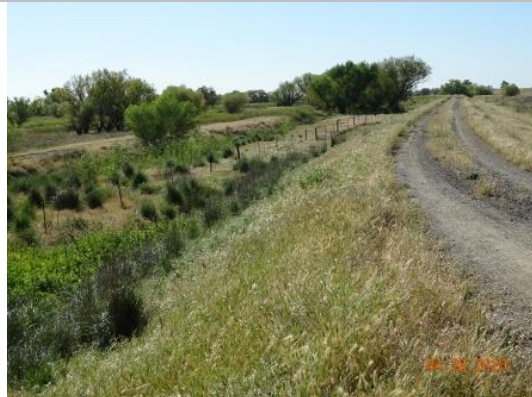
Photo 1 of 1 : SP_2020_NA0010_123_191_20200506_00345.jpg

LM Start	3.21	Rating **	U	Issue No.	191
LM End	3.62	Issue Type +	Ma	Location *	LS
Category	Earthen Levee			GPS Latitude/Longitude	
				Start	End
Item	Vegetation			37.256518 °	37.255676 °
				-120.778807 °	-120.771932 °
DWR ID	DWR_NA0010_05_s_2020_191				
Comment Code					
V1 : Control annual grass and weeds on the levee slopes and easements.					
Inspector Comment

Looking upstream along the landside slope. (Spring 2020)

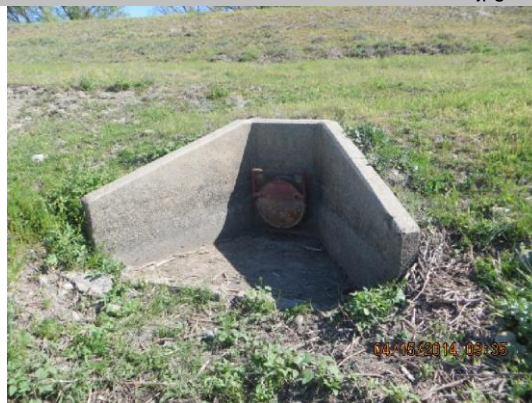
Photo 2 of 3 : UCIP_SP_2020_43055_60946.jpg

Flapgate and Concrete headwall at WS toe.

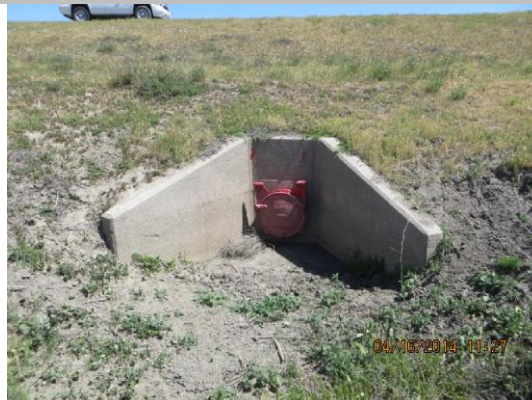
Photo 2 of 3 : UCIP_SP_2020_39586_61138.jpg

Pipe, headwall, and flapgate on WS toe.

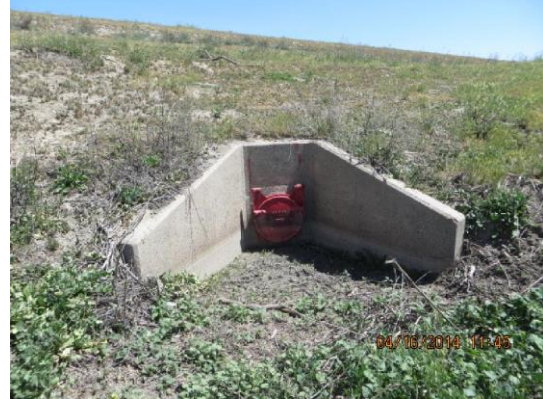
Photo 2 of 3 : UCIP_SP_2020_39880_61143.jpg

Pipe, headwall, and flapgate on WS toe.

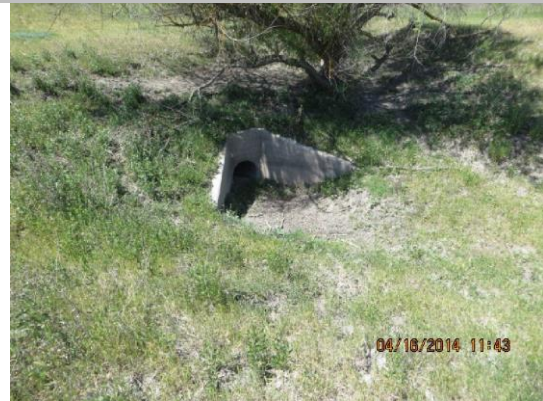
Photo 3 of 3 : UCIP_SP_2020_39880_61141.jpg

Pipe and headwall on LS toe.

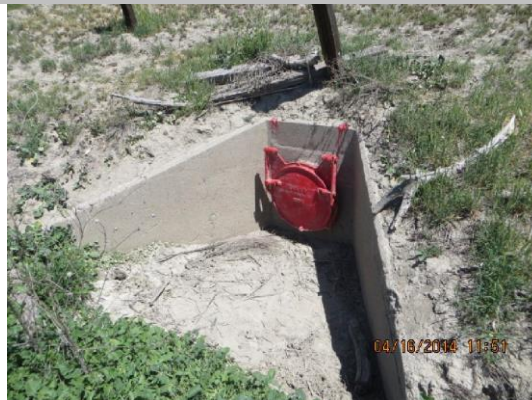
Photo 2 of 3 : UCIP_SP_2020_39588_61145.jpg

Pipe, headwall, and flapgate on WS toe.

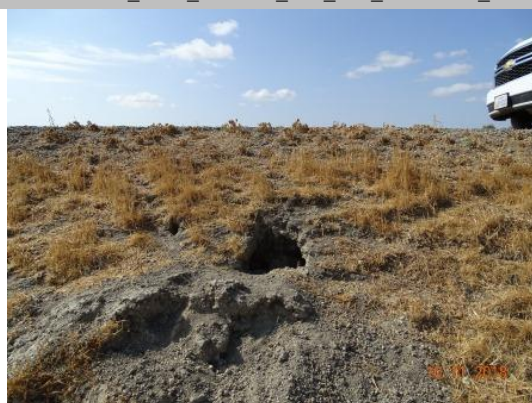
Photo 1 of 1 : SP_2020_NA0010_123_131_20200225_00033.jpg

LM Start	4.33	Rating **	U	Issue No.	131
LM End	4.33	Issue Type +	Ma	Location *	LS
Category	Earthen Levee			GPS Latitude/Longitude	
				Start	End
Item	Animal Control			37.245406 °	37.245406 °
				-120.759971 °	-120.759971 °
DWR ID	DWR_NA0010_05_f_2018_131				
Comment Code					
A3 : No rodents visible, but rodent burrows visible; need to backfill and compact or grout burrows.					
Inspector Comment					
Several large rodent holes are located on both sides of levee.

View of a large rodent hole in landward slope. (Fall 2018)

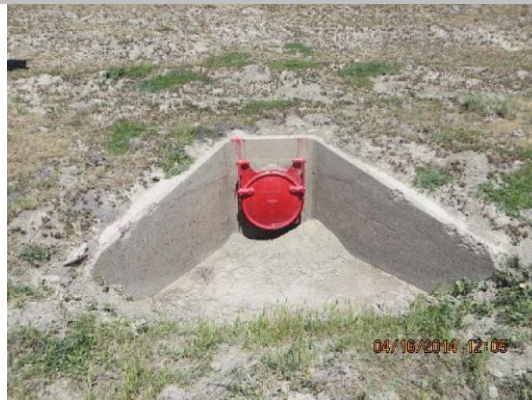
Photo 1 of 3 : UCIP_SP_2020_39590_62087.jpg

Comment Code						
Inspector Comment						
DS_ID:19772						
FS_ID:39590						
EP_NO: N/A						
Repair Type: Non-Urgent						
Crossing Status: Found						
UCIP Comments: 04/16/2014 Heavy sediment buildup in pipe visible from landward side--recommend contacting owner to clear pipe. (DWR UCIP - W. Wylie)						
FIELD_STRUCT_DESC: 24-inch corrugated metal gravity drainage pipe through the levee, 12.3 feet below the crown. Flap gate on the waterside (WS) end. Concrete headwall on the landside (LS) end. Concrete U-shaped headwall on the WS end. [Additional Reference(s): DWR Levee Log, 2002. USACE San Joaquin O&M Manual 601.1, 1967, (HLM 4.89)].						
FS Date: 4/16/2014

Headwall, flapgate, and pipe on WS toe.

Headwall and pipe on LS toe.

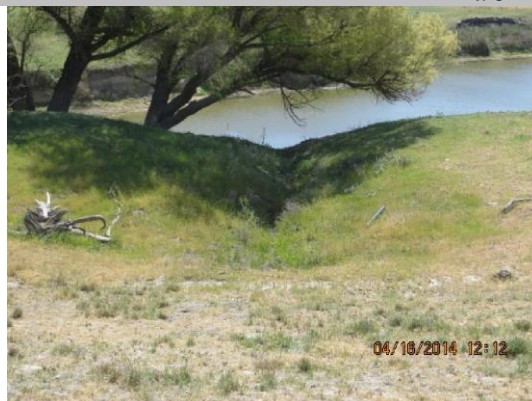
Photo 1 of 3 : UCIP_SP_2020_39591_62091.jpg

DS_ID:19773
 FS_ID:39591
 EP_NO: N/A
 Repair Type: Non-Urgent
 Crossing Status: Found
 UCIP Comments: 04/16/2014 Heavy sediment buildup in pipe visible from landward side--recommend contacting owner to clear pipe. (DWR UCIP - W. Wylie)
 FIELD_STRUCT_DESC: 24-inch corrugated metal gravity drainage pipe through the levee, 12.2 feet below the crown. Flap gate on the waterside (WS) end. Concrete headwall on the landside (LS) end. Concrete U-shaped headwall on the WS end. [Additional Reference(s): DWR Levee Log, 2002. USACE San Joaquin O&M Manual 601.1, 1967, (HLM 5.15)].
 FS Date: 4/16/2014

Headwall, flapgate, and pipe on WS toe.

Headwall, flapgates, and pipe on WS toe.

Headwall and pipe on LS toe.

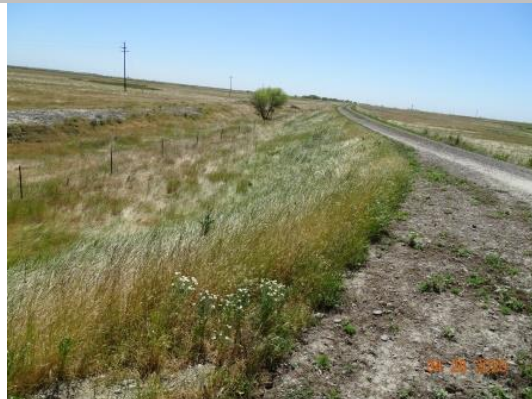
Photo 1 of 1 : SP_2020_NA0010_123_196_20200507_00346.jpg

LM Start	5.41	Rating **	U	Issue No.	196
LM End	8.09	Issue Type +	Ma	Location *	LS
Category	Earthen Levee			GPS Latitude/Longitude	
				Start	End
Item	Vegetation			37.240253 °	37.213570 °
				-120.742301 °	-120.706554 °
DWR ID	DWR_NA0010_05_s_2020_196				
Comment Code					
V1 : Control annual grass and weeds on the levee slopes and easements.					
Inspector Comment

View of the landside slope looking upstream. (Spring 2020)

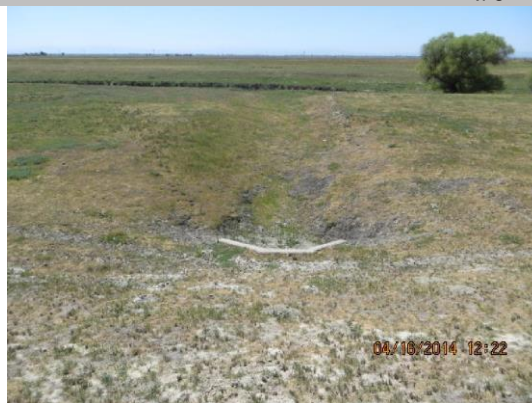
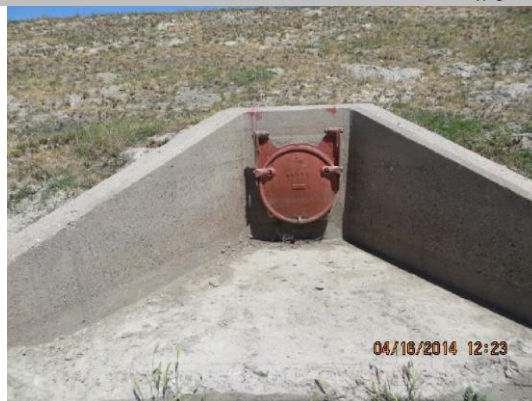
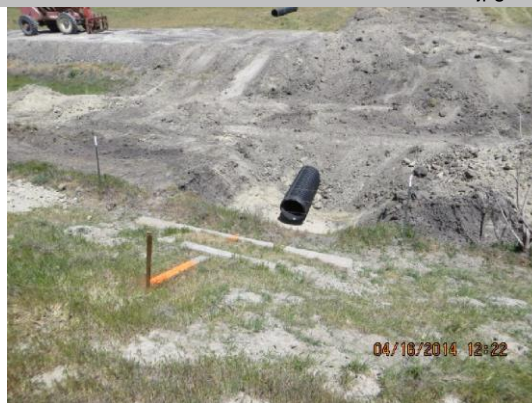
Photo 1 of 3 : UCIP_SP_2020_34151_62096.jpg

LM Start	5.58	Rating **	A/W	Issue No.	1325
LM End	5.58	Issue Type +	Ma	Location *	
Category	Supplemental			GPS Latitude/Longitude	
				Start	End
Item	DWR UCIP LMA Responsibility			37.238879 °	37.238879 °
				-120.739719 °	-120.739719 °
DWR ID	19774				
Comment Code					
Inspector Comment					
DS_ID:19774					
FS_ID:34151					
EP_NO: N/A					
Repair Type: No Action Needed					
Crossing Status: Found					
UCIP Comments:					
FIELD_STRUCT_DESC: 24-inch corrugated metal gravity drainage pipe through the levee, 9.5 feet below the crown. Flap gate on the waterside (WS) end. Concrete headwall on the landside (LS) end. Concrete U-shaped headwall on the WS end. [Additional Reference(s): DWR Levee Log, 2002. USACE San Joaquin O&M Manual 601.1, 1967, (HLM 5.58)].					
FS Date: 4/16/2014

Headwall, flapgate, and pipe on WS toe.

Headwall and pipe on LS toe with HDPE drain pipe being installed off LS toe.

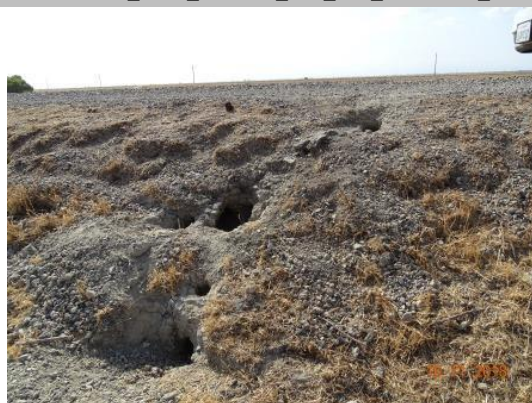
Photo 1 of 1 : SP_2020_NA0010_123_138_20200225_00038.jpg

LM Start	5.94	Rating **	U	Issue No.	138
LM End	5.94	Issue Type +	Ma	Location *	LS
Category	Earthen Levee			GPS Latitude/Longitude	
				Start	End
Item	Animal Control			37.236387 °	37.236387 °
				-120.734164 °	-120.734164 °
DWR ID	DWR_NA0010_05_f_2018_138				
Comment Code					
A1 : Exterminate rodents and backfill and compact or grout burrows.					
Inspector Comment					
Several large rodent holes are located at this location.

View of large rodent holes in landside slope. (Fall 2018)

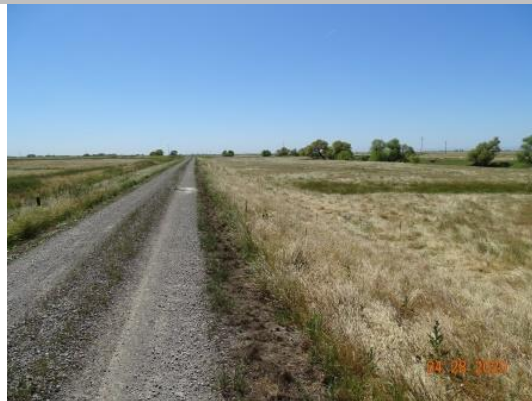
Photo 1 of 1 : SP_2020_NA0010_123_198_20200507_00347.jpg

LM Start	6.32	Rating **	U	Issue No.	198
LM End	7.77	Issue Type +	Ma	Location *	WS
Category	Earthen Levee			GPS Latitude/Longitude	
				Start	End
Item	Vegetation			37.232897 °	37.216634 °
				-120.729075 °	-120.710815 °
DWR ID	DWR_NA0010_05_s_2020_198				
Comment Code					
V1 : Control annual grass and weeds on the levee slopes and easements.					
Inspector Comment

Looking upstream along the waterside slope. (Spring 2020)

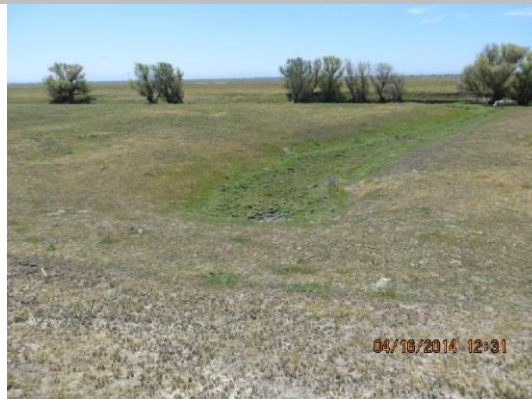
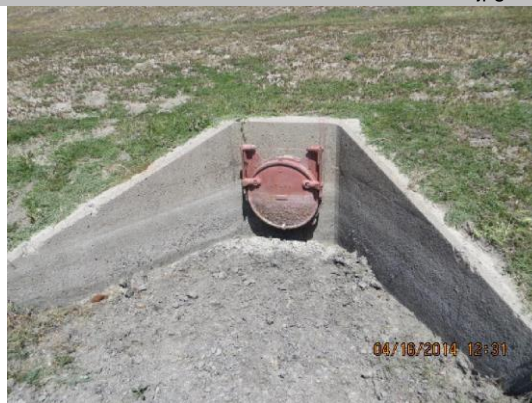
Photo 1 of 3 : UCIP_SP_2020_34163_62102.jpg

LM Start	6.35	Rating **	A/W	Issue No.	1326
LM End	6.35	Issue Type +	Ma	Location *	
Category	Supplemental			GPS Latitude/Longitude	
				Start	End
Item	DWR UCIP LMA Responsibility			37.232589 °	37.232589 °
				-120.728822 °	-120.728822 °
DWR ID	19775				
Comment Code					
Inspector Comment					
DS_ID:19775 FS_ID:34163 EP_NO: N/A Repair Type: No Action Needed Crossing Status: Found UCIP Comments: FIELD_STRUCT_DESC: 24-inch corrugated metal gravity drainage pipe through the levee, 13 feet below the crown. Flap gate on the waterside (WS) end. Concrete headwall on the landside (LS) end. Concrete U-shaped headwall on the WS end. [Additional Reference(s): DWR Levee Log, 2002. USACE San Joaquin O&M Manual 601.1, 1967, (HLM 6.35)]. FS Date: 4/16/2014

Headwall, flapgate, and pipe on WS toe.

Headwall and pipe on LS toe.

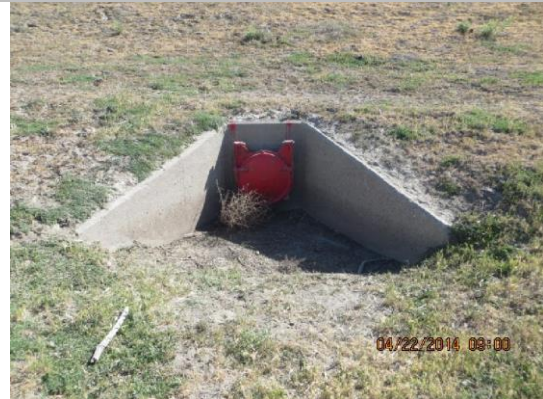
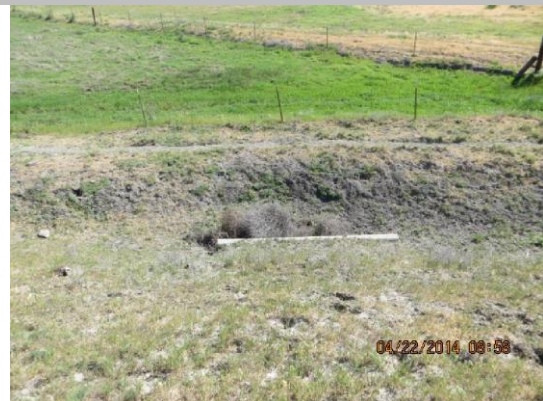
Photo 1 of 3 : UCIP_SP_2020_39592_62111.jpg

LM Start	7.36	Rating **	M	Issue No.	1327	
LM End	7.36	Issue Type +	Ma	Location *		
Category	Supplemental			GPS Latitude/Longitude		
				Start		End
Item	DWR UCIP LMA Responsibility			37.224560 °		37.224560 °
				-120.714057 °		-120.714057 °
DWR ID	19761					
Comment Code						
Inspector Comment						
DS_ID:19761 FS_ID:39592 EP_NO: N/A Repair Type: Non-Urgent Crossing Status: Found UCIP Comments: 04/22/2014 Sediment buildup in pipe visible from landward side--recommend contacting owner to clear pipe. (DWR UCIP - W. Wylie) FIELD_STRUCT_DESC: 24-inch corrugated metal gravity drainage pipe through the levee, 12 feet below the crown. Flap gate on the waterside (WS) end. Concrete headwall on the landside (LS) end. Concrete U-shaped headwall on the waterside (WS) end. [Additional Reference(s): DWR Levee Log, 2002. USACE San Joaquin O&M Manual 601.1, 1967, (HLM 7.36)]. FS Date: 4/22/2014

Headwall, flapgate, and pipe on WS toe.

Headwall and pipe on LS toe.

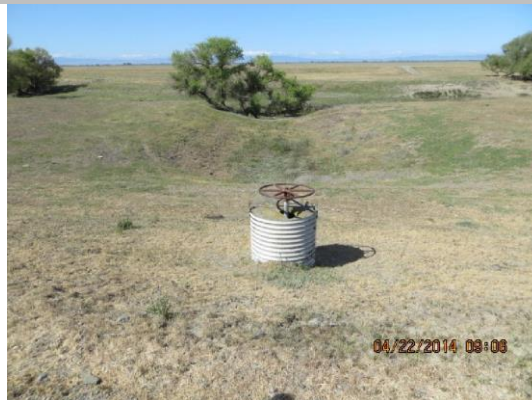
Photo 2 of 2 : UCIP_SP_2020_34170_62115.jpg

Comment Code						
Inspector Comment						
DS_ID:19762 FS_ID:34170 EP_NO: N/A Repair Type: Non-Urgent Crossing Status: Indicator Found UCIP Comments: 04/22/2014 Appears abandoned and if so should be done so properly. Slide gate rusted shut on WS slope. Unable to locate inlet or outlet. (DWR UCIP - W. Wylie) FIELD_STRUCT_DESC: 24-inch corrugated metal gravity drainage pipe through the levee, 20.4 feet below the crown. Slide gate in 36-inch corrugated metal pipe (CMP) riser on the waterside (WS) slope. Concrete U-shaped headwall on each end. Not found in 2014. [Additional Reference(s): DWR Levee Log, 2002. USACE San Joaquin O&M Manual 601.1, 1967, (HLM 7.58)]. FS Date: 4/22/2014

Slide gate in CMP riser on WS slope. No outlet or pipe found on WS toe.

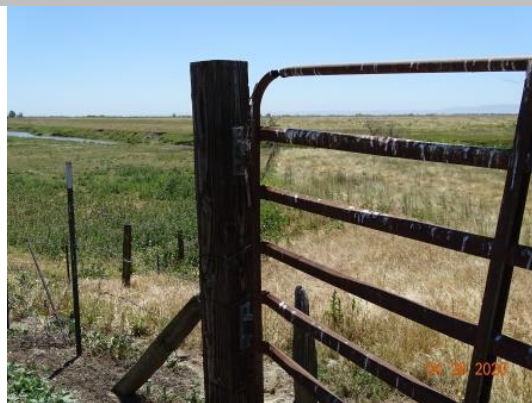
Photo 1 of 1 : SP_2020_NA0010_123_104_20200507_00348.jpg

LM Start	8.09	Rating **	M	Issue No.	104
LM End	8.09	Issue Type +	Ma	Location *	CR
Category	Earthen Levee			GPS Latitude/Longitude	
				Start	End
Item	Repair Gates			37.213580 °	37.213580 °
				-120.706550 °	-120.706550 °
DWR ID	DWR_NA0010_05_s_2017_104				
Comment Code					
Inspector Comment					
The gate is not opening correctly due to a bent fence post.

Gate is broken near the hinge. (Spring 2020)

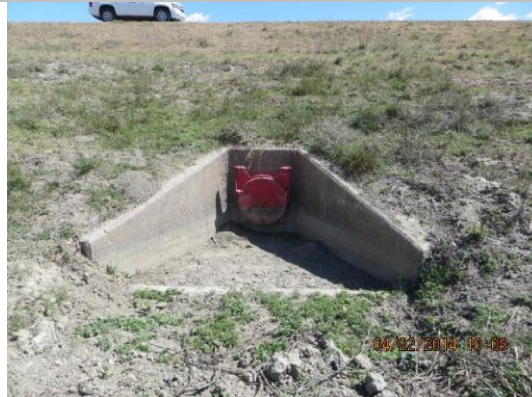
Photo 2 of 3 : UCIP_SP_2020_34265_62183.jpg

Headwall, flapgate, and pipe on WS toe

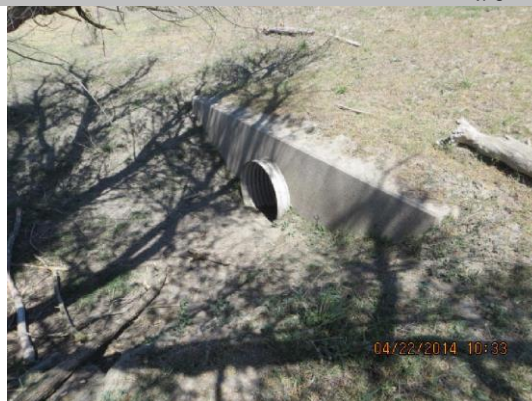
Photo 2 of 3 : UCIP_SP_2020_34272_62198.jpg

Headwall and pipe at WS toe.

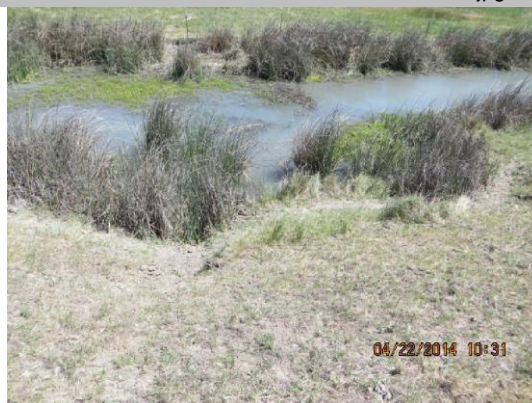
Photo 3 of 3 : UCIP_SP_2020_34272_62197.jpg

Headwall and pipe at LS toe.

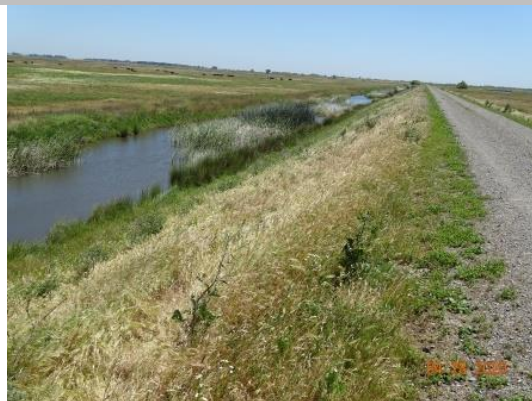
Photo 1 of 1 : SP_2020_NA0010_123_200_20200507_00349.jpg

LM Start	9.51	Rating **	U	Issue No.	200
LM End	10.33	Issue Type +	Ma	Location *	LS
Category	Earthen Levee			GPS Latitude/Longitude	
				Start	End
Item	Vegetation			37.200555 °	37.191923 °
				-120.686897 °	-120.676784 °
DWR ID	DWR_NA0010_05_s_2020_200				
Comment Code					
V1 : Control annual grass and weeds on the levee slopes and easements.					
Inspector Comment

View of vegetation along the landside slope. (Spring 2020)

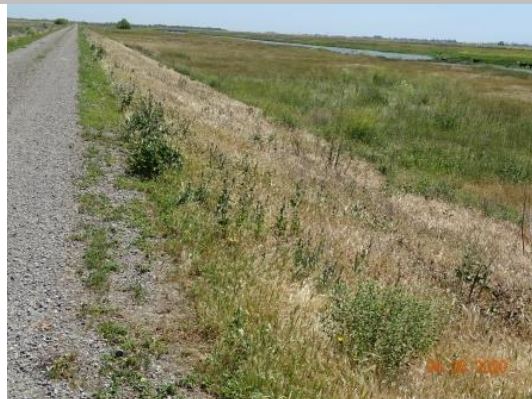
Photo 1 of 1 : SP_2020_NA0010_123_201_20200507_00350.jpg

LM Start	9.51	Rating **	M	Issue No.	201
LM End	10.33	Issue Type +	Ma	Location *	WS
Category	Earthen Levee			GPS Latitude/Longitude	
				Start	End
Item	Vegetation			37.200554 °	37.191923 °
				-120.686897 °	-120.676784 °
DWR ID	DWR_NA0010_05_s_2020_201				
Comment Code					
V1 : Control annual grass and weeds on the levee slopes and easements.					
Inspector Comment

Looking upstream along the waterside slope. (Spring 2020)

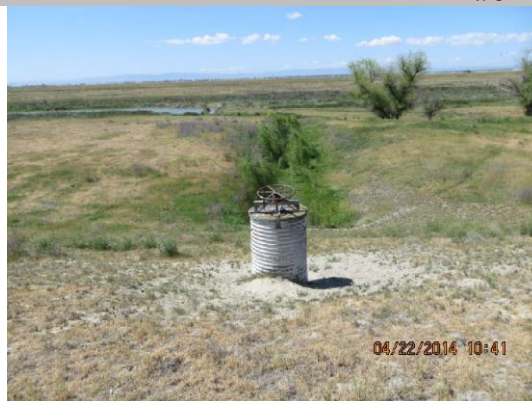
Photo 1 of 3 : UCIP_SP_2020_34273_62201.jpg

Slidegate in CMP riser on WS slope.

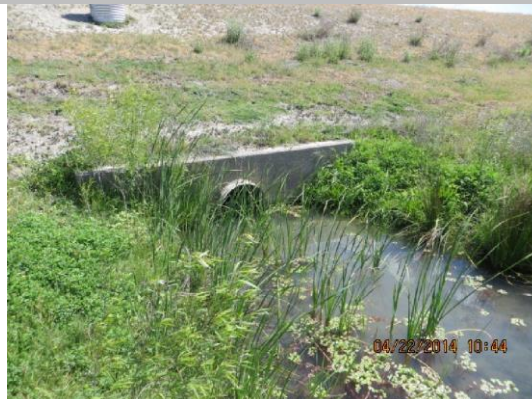
Photo 2 of 3 : UCIP_SP_2020_34273_62202.jpg

Concrete headwall and pipe on WS toe.

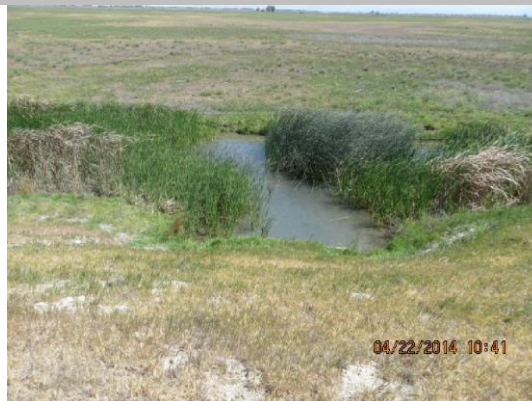
Photo 3 of 3 : UCIP_SP_2020_34273_62200.jpg

Concrete headwall and pipe on LS toe.

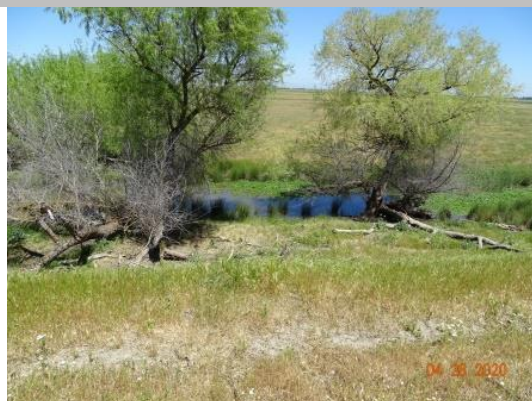
Photo 1 of 1 : SP_2020_NA0010_123_144_20200507_00351.jpg

LM Start	11.37	Rating **	M	Issue No.	144
LM End	11.37	Issue Type +	Ma	Location *	LS
Category	Earthen Levee			GPS Latitude/Longitude	
				Start	End
Item	Trim / Thin Trees			37.187792 °	37.187792 °
				-120.659454 °	-120.659454 °
DWR ID	DWR_NA0010_05_f _ 2018_144				
Comment Code					
T2 : Thin trees to allow visibility of the ground and room to flood fight.					
Inspector Comment					
Tree limbs on the levee slope should be trimmed to allow access.

View of tree limbs on levee slope. (Spring 2020)

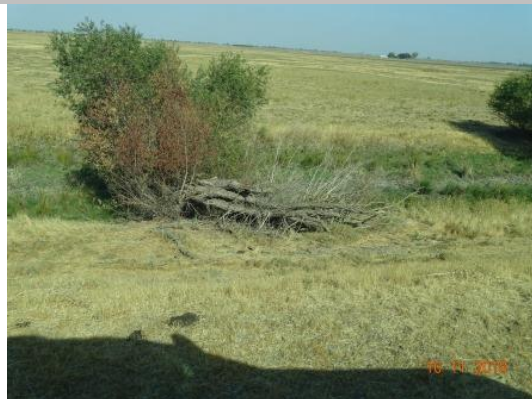
Photo 1 of 1 : SP_2020_NA0010_123_145_20200225_00045.jpg

LM Start	11.41	Rating **	M	Issue No.	145
LM End	11.41	Issue Type +	Ma	Location *	LS
Category	Earthen Levee			GPS Latitude/Longitude	
				Start	End
Item	Trim / Thin Trees			37.187404 °	37.187404 °
				-120.659005 °	-120.659005 °
DWR ID	DWR_NA0010_05_f _ 2018_145				
Comment Code					
T2 : Thin trees to allow visibility of the ground and room to flood fight.					
Inspector Comment					
A fallen tree trunk is located on the levee toe.

Fallen tree on levee toe. (Fall 2018)

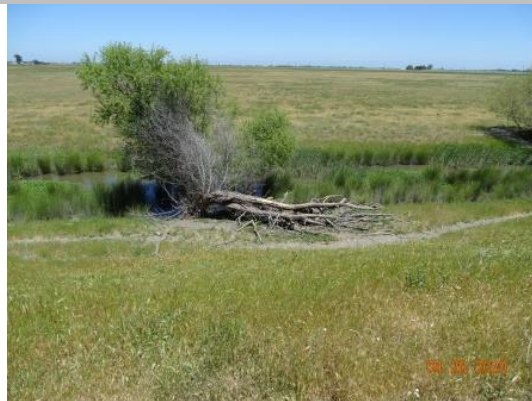
Photo 1 of 1 : SP_2020_NA0010_123_146_20200507_00352.jpg

LM Start	11.44	Rating **	M	Issue No.	146
LM End	11.44	Issue Type +	Ma	Location *	LS
Category	Earthen Levee			GPS Latitude/Longitude	
				Start	End
Item	Trim / Thin Trees			37.187021 °	37.187021 °
				-120.658564 °	-120.658564 °
DWR ID	DWR_NA0010_05_f _ 2018_146				
Comment Code					
T2 : Thin trees to allow visibility of the ground and room to flood fight.					
Inspector Comment					
Fallen tree limbs are located on the levee toe.

Tree limbs and trunk on levee toe. (Spring 2020)

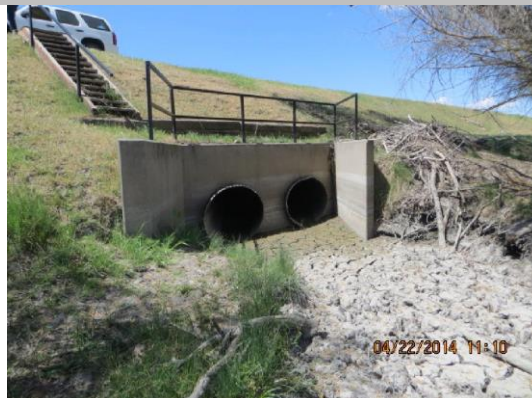
Photo 2 of 3 : UCIP_SP_2020_34281_62217.jpg

Stairs, concrete headwall, and pipe visible on LS slope.

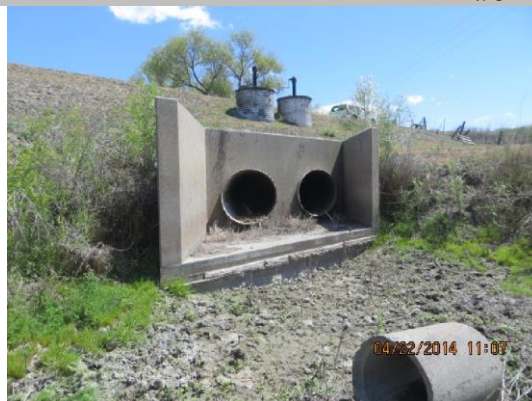
Photo 1 of 3 : UCIP_SP_2020_34280_62216.jpg

Concrete headwall, pipe, and slidegate in CMP riser on WS of levee.

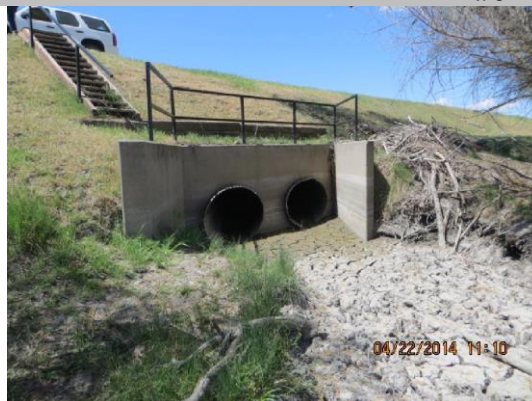
Photo 2 of 3 : UCIP_SP_2020_34280_62214.jpg

Stairs, concrete headwall and pipe on LS toe.

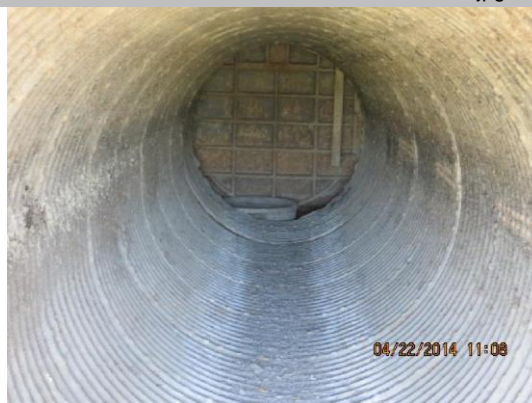
Photo 3 of 3 : UCIP_SP_2020_34280_62215.jpg

Inside pipe on WS toe.

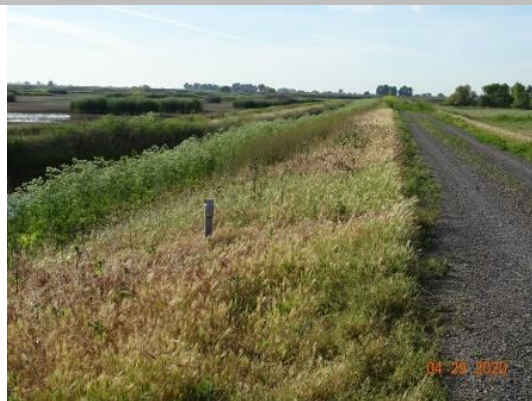
Photo 1 of 1 : SP_2020_NA0010_123_204_20200507_00354.jpg

LM Start	11.54	Rating **	U	Issue No.	204
LM End	13.74	Issue Type +	Ma	Location *	LS
Category	Earthen Levee			GPS Latitude/Longitude	
				Start	End
Item	Vegetation			37.185926 °	37.167963 °
				-120.657317 °	-120.629655 °
DWR ID	DWR_NA0010_05_s_2020_204				
Comment Code					
V1 : Control annual grass and weeds on the levee slopes and easements.					
Inspector Comment

View of vegetation on the landside slope. (Spring 2020)

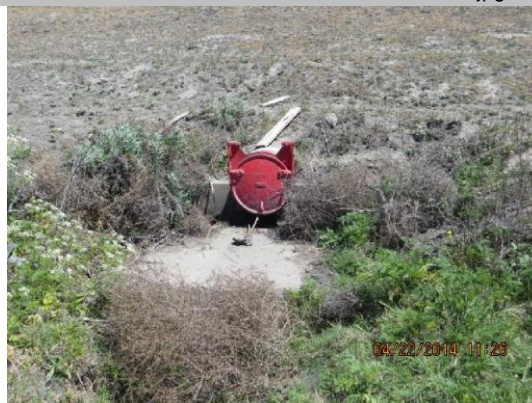
LM Start	11.65	Rating **	A/W	Issue No.	1335
LM End	11.65	Issue Type +	Ma	Location *	
Category	Supplemental			GPS Latitude/Longitude	
				Start	End
Item	DWR UCIP LMA Responsibility			37.184830 °	37.184830 °
				-120.656016 °	-120.656016 °
DWR ID	19704				
Comment Code					
Inspector Comment					
DS_ID:19704 FS_ID:34283 EP_NO: N/A Repair Type: No Action Needed Crossing Status: Found UCIP Comments: FIELD_STRUCT_DESC: 24-inch corrugated metal gravity drainage pipe through the levee, 11.8 feet below the crown. Flap gate on the waterside (WS) end. Concrete headwall on the landside (LS) end. Concrete saddle and apron on the WS end. [Additional Reference(s): DWR Levee Log, 2002. USACE San Joaquin O&M Manual 601.1, 1967, (HLM 11.63)]. FS Date: 4/22/2014

Headwall, flapgate, and pipe at WS toe.

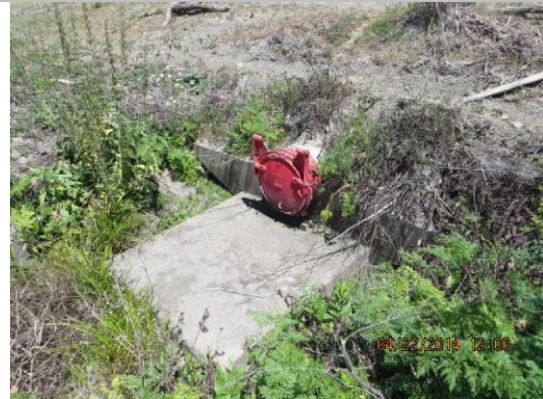
Headwall, flapgate, and pipe on WS toe.

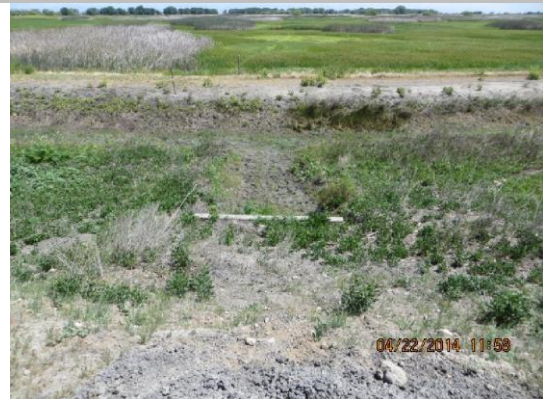
Headwall and pipe on LS toe.

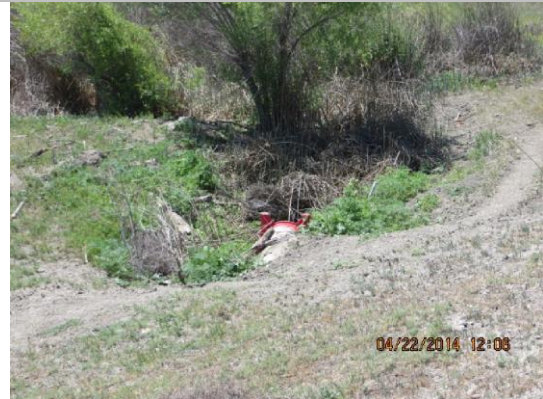
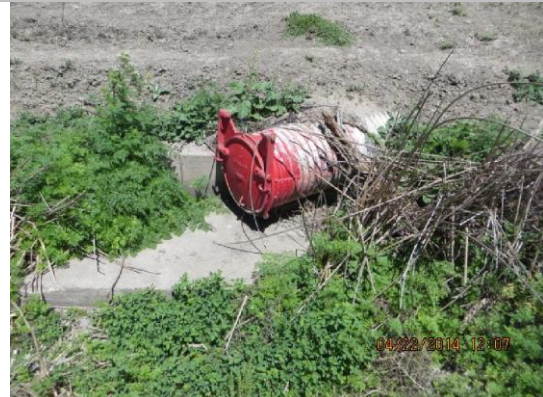
LM Start	12.40	Rating **	A/W	Issue No.	1337
LM End	12.40	Issue Type +	Ma	Location *	
Category	Supplemental			GPS Latitude/Longitude	
				Start	End
Item	DWR UCIP LMA Responsibility			37.175958 °	37.175958 °
				-120.649798 °	-120.649798 °
DWR ID	19706				
Comment Code					
Inspector Comment					
DS_ID:19706					
FS_ID:34285					
EP_NO: N/A					
Repair Type: No Action Needed					
Crossing Status: Found					
UCIP Comments:					
FIELD_STRUCT_DESC: 24-inch corrugated metal gravity drainage pipe through the levee, 10.2 feet below the crown. Flap gate on the waterside (WS) end. Concrete headwall on the landside (LS) end. Concrete saddle and apron on the WS end. Flashboard attachment on the LS end. Pipe crosses levee at 45 degrees to crown alignment. [Additional Reference(s): DWR Levee Log, 2002. USACE San Joaquin O&M Manual 601.1, 1967, (HLM 12.38)].					
FS Date: 4/22/2014

Headwall, flapgate, and pipe on WS toe.

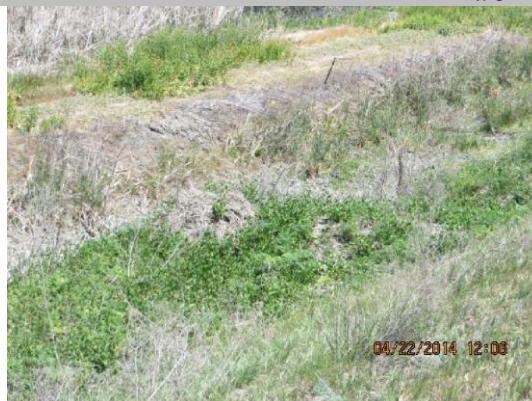
Headwall and pipe on LS toe.

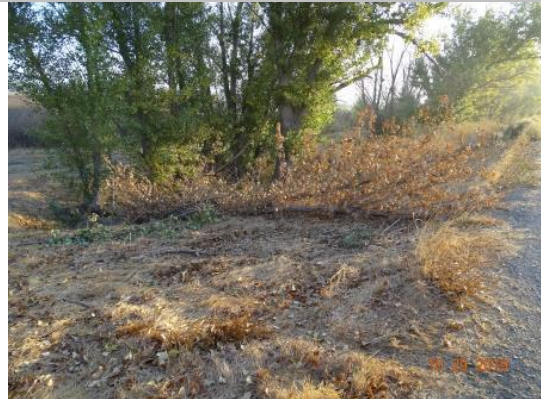
LM Start	12.88	Rating **	M	Issue No.	158
LM End	12.88	Issue Type +	Ma	Location *	LS
Category	Earthen Levee			GPS Latitude/Longitude	
				Start	End
Item	Encroachments			37.175807 °	37.175807 °
				-120.641139 °	-120.641139 °
DWR ID	DWR_NA0010_05_f_2019_158				
Comment Code					
TR : Tree or limb					
Inspector Comment					
Tree limb on the landside slope should be removed.

View of downed tree limb on the landside slope. (Fall 2019)

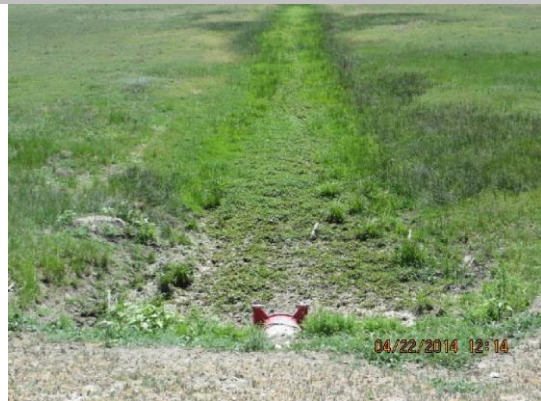
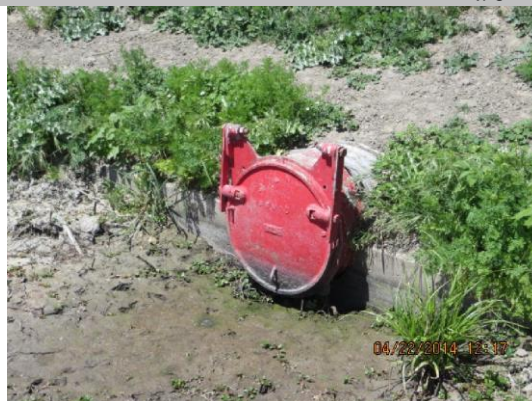
Comment Code						
Inspector Comment						
DS_ID:19707 FS_ID:39593 EP_NO: N/A Repair Type: Non-Urgent Crossing Status: Found UCIP Comments: 04/22/2014 Sediment buildup in pipe visible from landward side--recommend contacting owner to clear pipe. (DWR UCIP - W. Wylie) FIELD_STRUCT_DESC: 24-inch corrugated metal gravity drainage pipe through the levee, 10.2 feet below the crown. Concrete headwall on the landside (LS) end with flashboards. Concrete saddle and apron on the waterside (WS) end with a flap gate. Metal screen at LS toe inlet. [Additional Reference(s): DWR Levee Log, 2002. USACE San Joaquin O&M Manual 601.1, 1967, (HLM 12.87)]. FS Date: 4/22/2014

Headwall, flapgate, and pipe on WS toe.

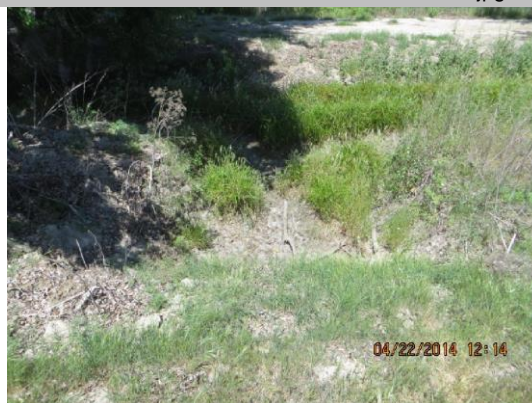
Headwall and pipe on LS toe.

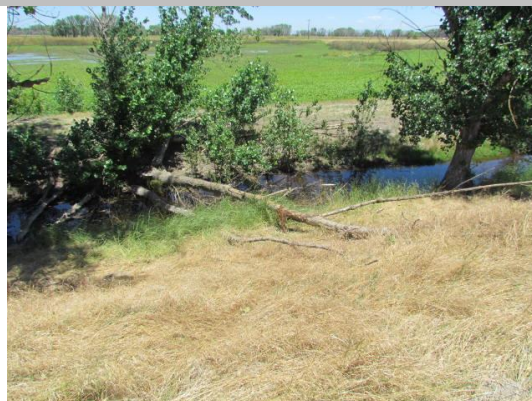
LM Start	13.01	Rating **	M	Issue No.	2
LM End	13.01	Issue Type +	Ma	Location *	LS
Category	Earthen Levee			GPS Latitude/Longitude	
				Start	End
Item	Encroachments			37.175576 °	37.175576 °
				-120.638755 °	-120.638755 °
DWR ID	DWR_NA0010_05_s_2016_2				
Comment Code					
TR : Tree or limb					
Inspector Comment					
There is a downed tree on landside toe.

Looking west at down tree at landward toe.

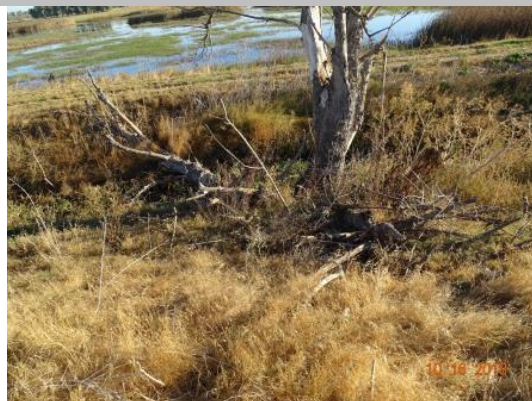
LM Start	13.05	Rating **	M	Issue No.	150
LM End	13.05	Issue Type +	Ma	Location *	LS
Category	Earthen Levee			GPS Latitude/Longitude	
				Start	End
Item	Encroachments			37.175314 °	37.175314 °
				-120.638034 °	-120.638034 °
DWR ID	DWR_NA0010_05_f _ 2018_150				
Comment Code					
TR : Tree or limb					
Inspector Comment					
There are tree trimmings on the levee slope and toe.

Tree trimmings on landside slope and toe. (Fall 2018)
